# PUBLIC ROADS

VOL. 9, NO. 10

# LOADING TESTS ON A REINFORCED CONCRETE ARCH

## REPORT ON TESTS MADE ON YADKIN RIVER BRIDGE IN NORTH CAROLINA

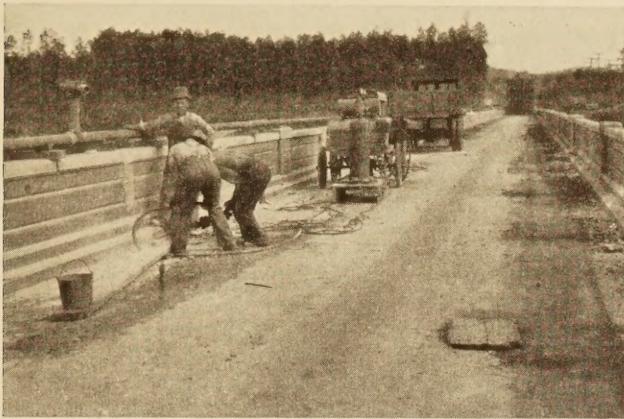
CUTTING THROUGH THE FLOOR SYSTEM AT A PANEL POINT TO DESTROY CONTINUITY

In destroying the continuity of the superstructure for series 2 and 3 the slab, girders, and handrail over each cross beam were cut through with air drills and the steel severed with an oxyacetylene flame. The ends of the girders were then jacked up and new, well-greased bearing plates inserted at each girder bearing. The girder ends on the entire east half of the span were shattered by the cutting operation to such an extent as to make the bearings on the cross beam unsafe. To relieve these bearings of the tank loads, holes were cut through the deck at the panel points and timber bearing blocks placed directly on the cross beams. In two panels it was thought necessary to support the dead weight of the floor system on timbering built up from the ribs. This was done in such a way that the arch was not stiffened.

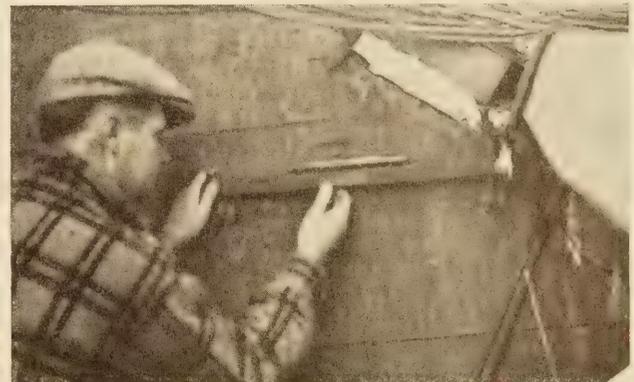
TAKING A ROTATION MEASUREMENT WITH A CLINOMETER

Two steel plugs containing gauge holes were grouted in the inner side of the rib in such a manner that they were 20 inches apart and approximately in the same horizontal plane and the line between the gauge holes was bisected by a plane normal to the axis at the point at which it was desired to measure the rotation. To measure the rotation under any increment of load, the points of the clinometer were placed in the gauge holes of the plugs and the level bubble brought to the center of the bubble tube by use of the adjusting screw and the micrometer dial read. After the load was applied, another reading was taken. The difference in the two readings was the relative vertical movement of the two plugs in thousandths of an inch, and this change in relative elevation divided by the gauge length gave the rotation in radians.
